Tilcon New Jersey – Pompton Lakes Quarry

Blast Monitoring Review

Prepared by Vibra-Tech Engineers, Inc.
May 19, 2022

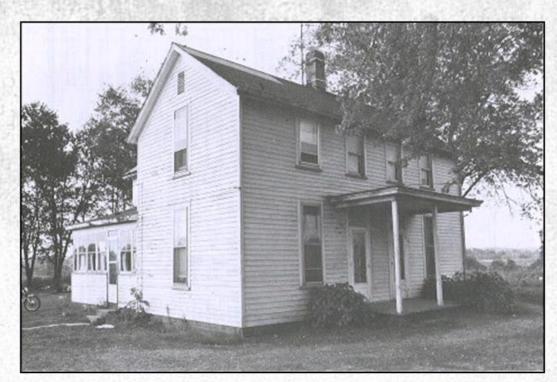
Older Plaster-on-Lath Interiors

Structures from USBM RI-8507

2 Story Brick

1 Story Wood Frame

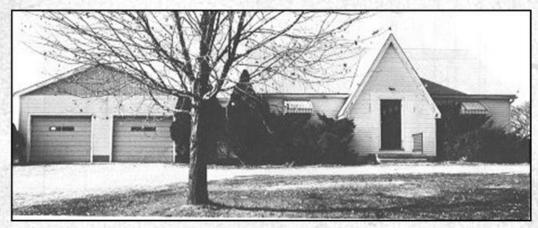
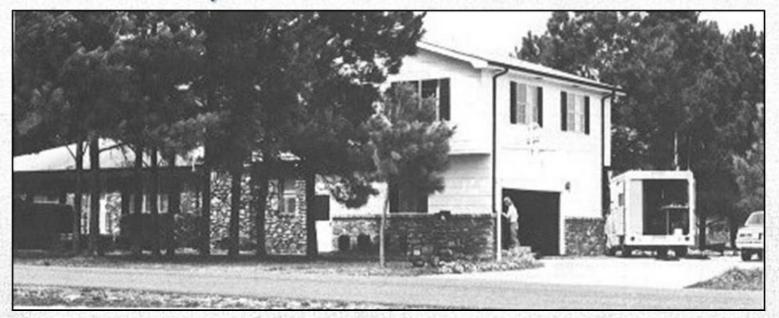
Modern Gypsum Wallboard Interiors

Structures from USBM RI-8507

11/2 Story Wood Frame

1 Story Wood Frame

2 Story Wood Frame
