**Tilcon New Jersey
Pompton Lakes Quarry
Quarterly Blast Compliance Summary
1st Quarter 2019**

Comparison of Measured Blast Vibrations to Current U.S. Bureau of Mines Recommendations Tilcon New Jersey Pompton Lakes Quarry 1st Quarter 2019

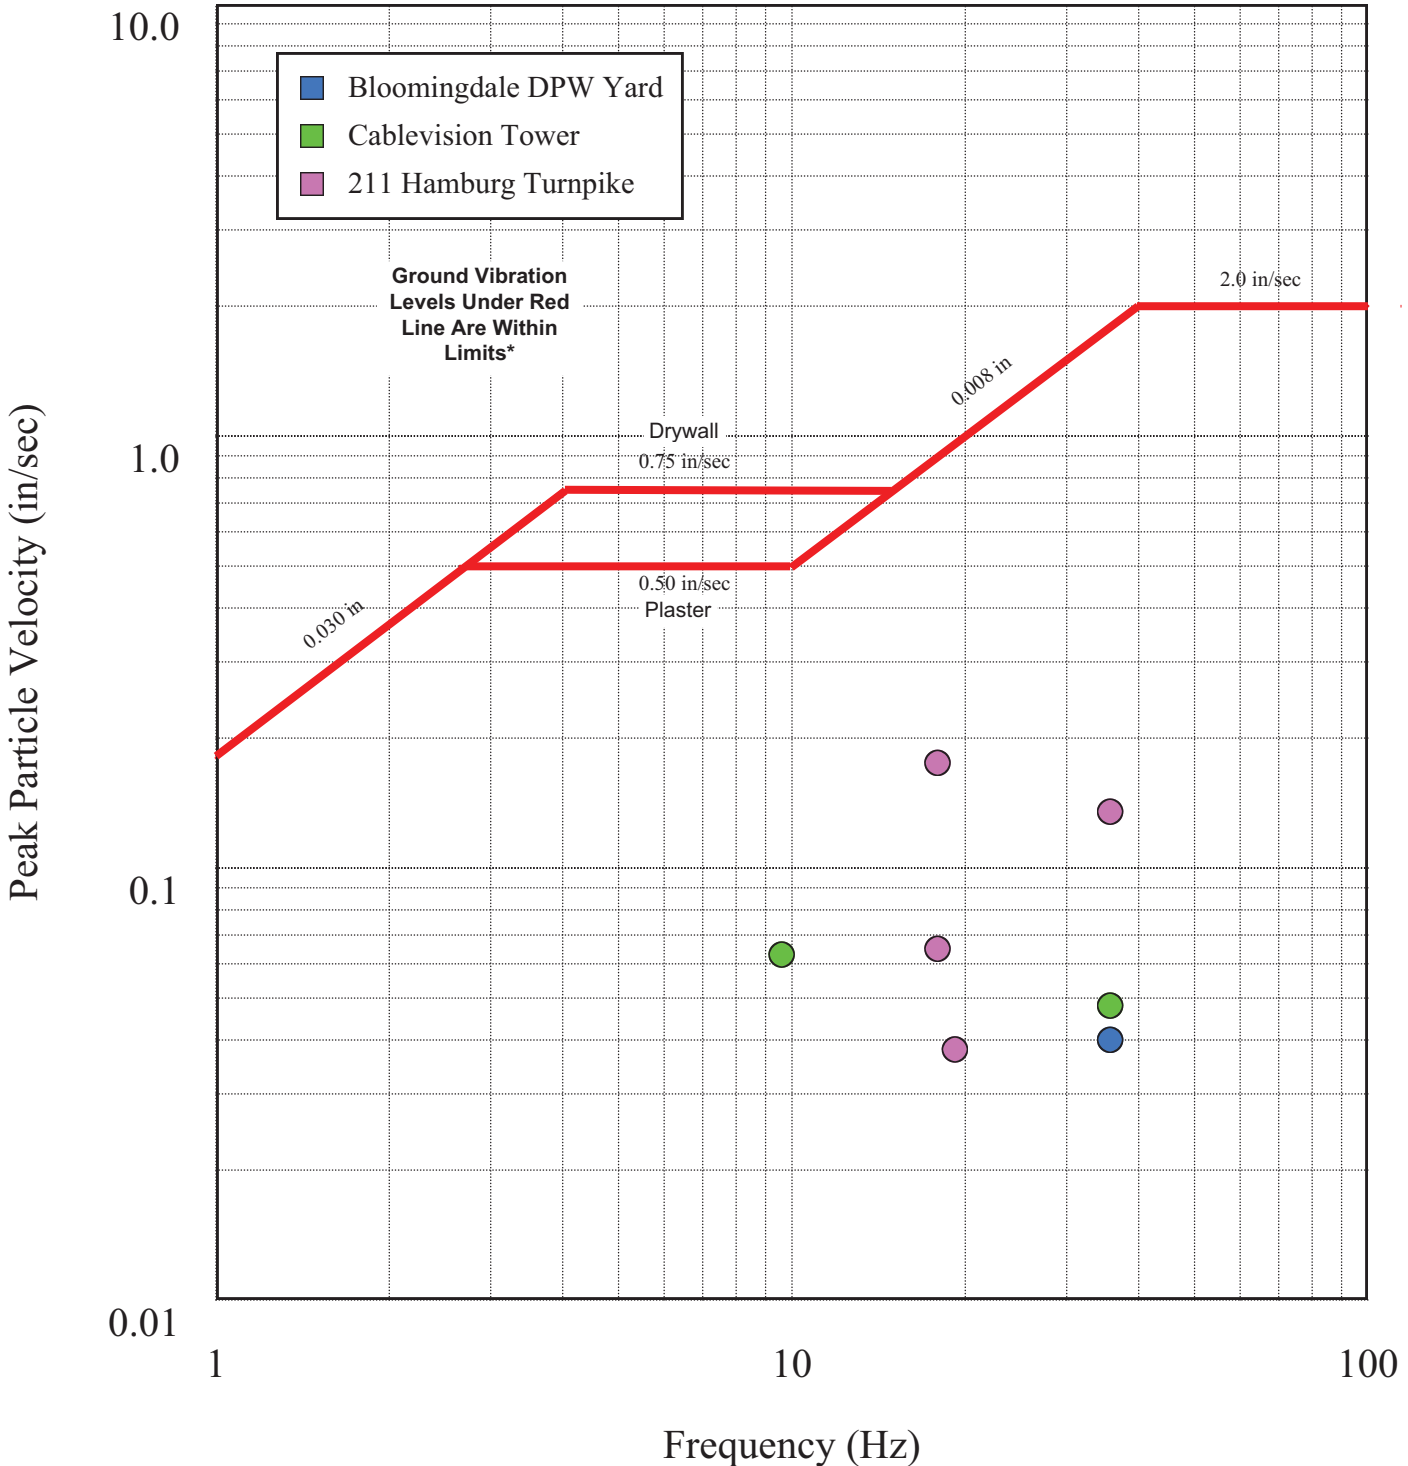
As per State of New Jersey Administrative Code Title 12:190; Subchapter 7.26

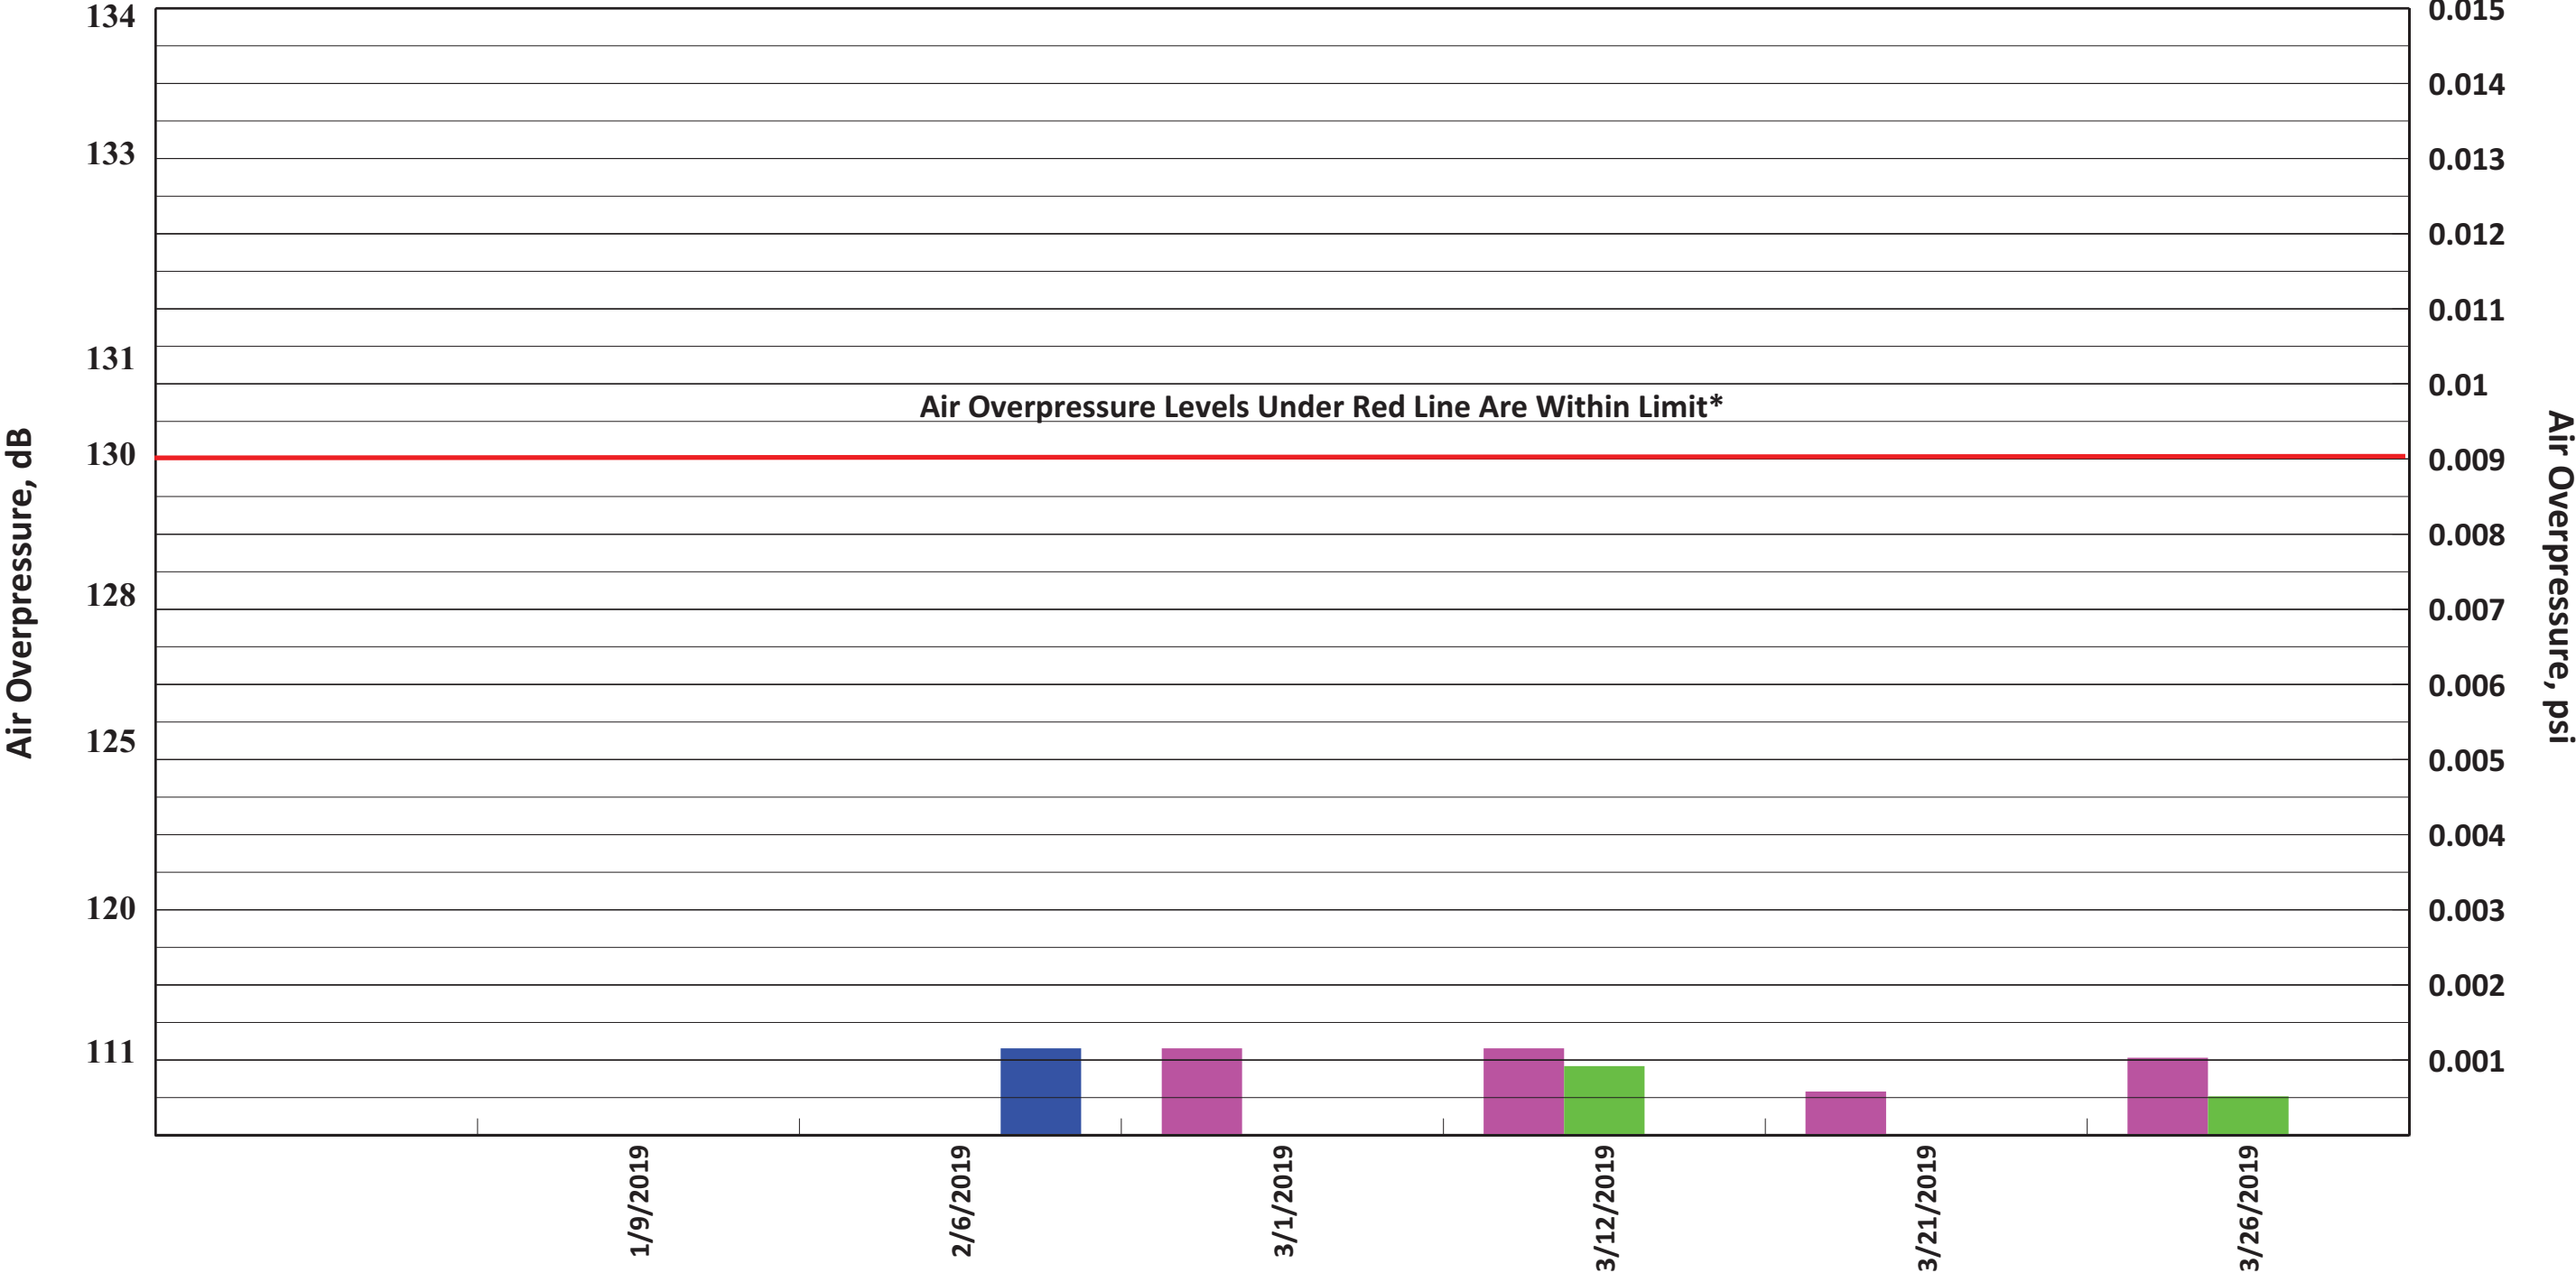
Air Overpressure Levels from Tilcon New Jersey - Pompton Lakes Quarry 1st Quarter 2019

*As per State of New Jersey Administrative Code Title 12.190; Subchapter 7.25

211 Hamburg Turnpike
 Cablevision Tower
 Bloomingdale DPW Yard
