**Tilcon New Jersey
Pompton Lakes Quarry
Quarterly Blast Compliance Summary
3rd Quarter 2018**

Comparison of Measured Blast Vibrations to Current U.S. Bureau of Mines Recommendations Tilcon New Jersey Pompton Lakes Quarry 3rd Quarter 2018

Air Overpressure Levels from Tilcon New Jersey - Pompton Lakes Quarry 3rd Quarter 2018

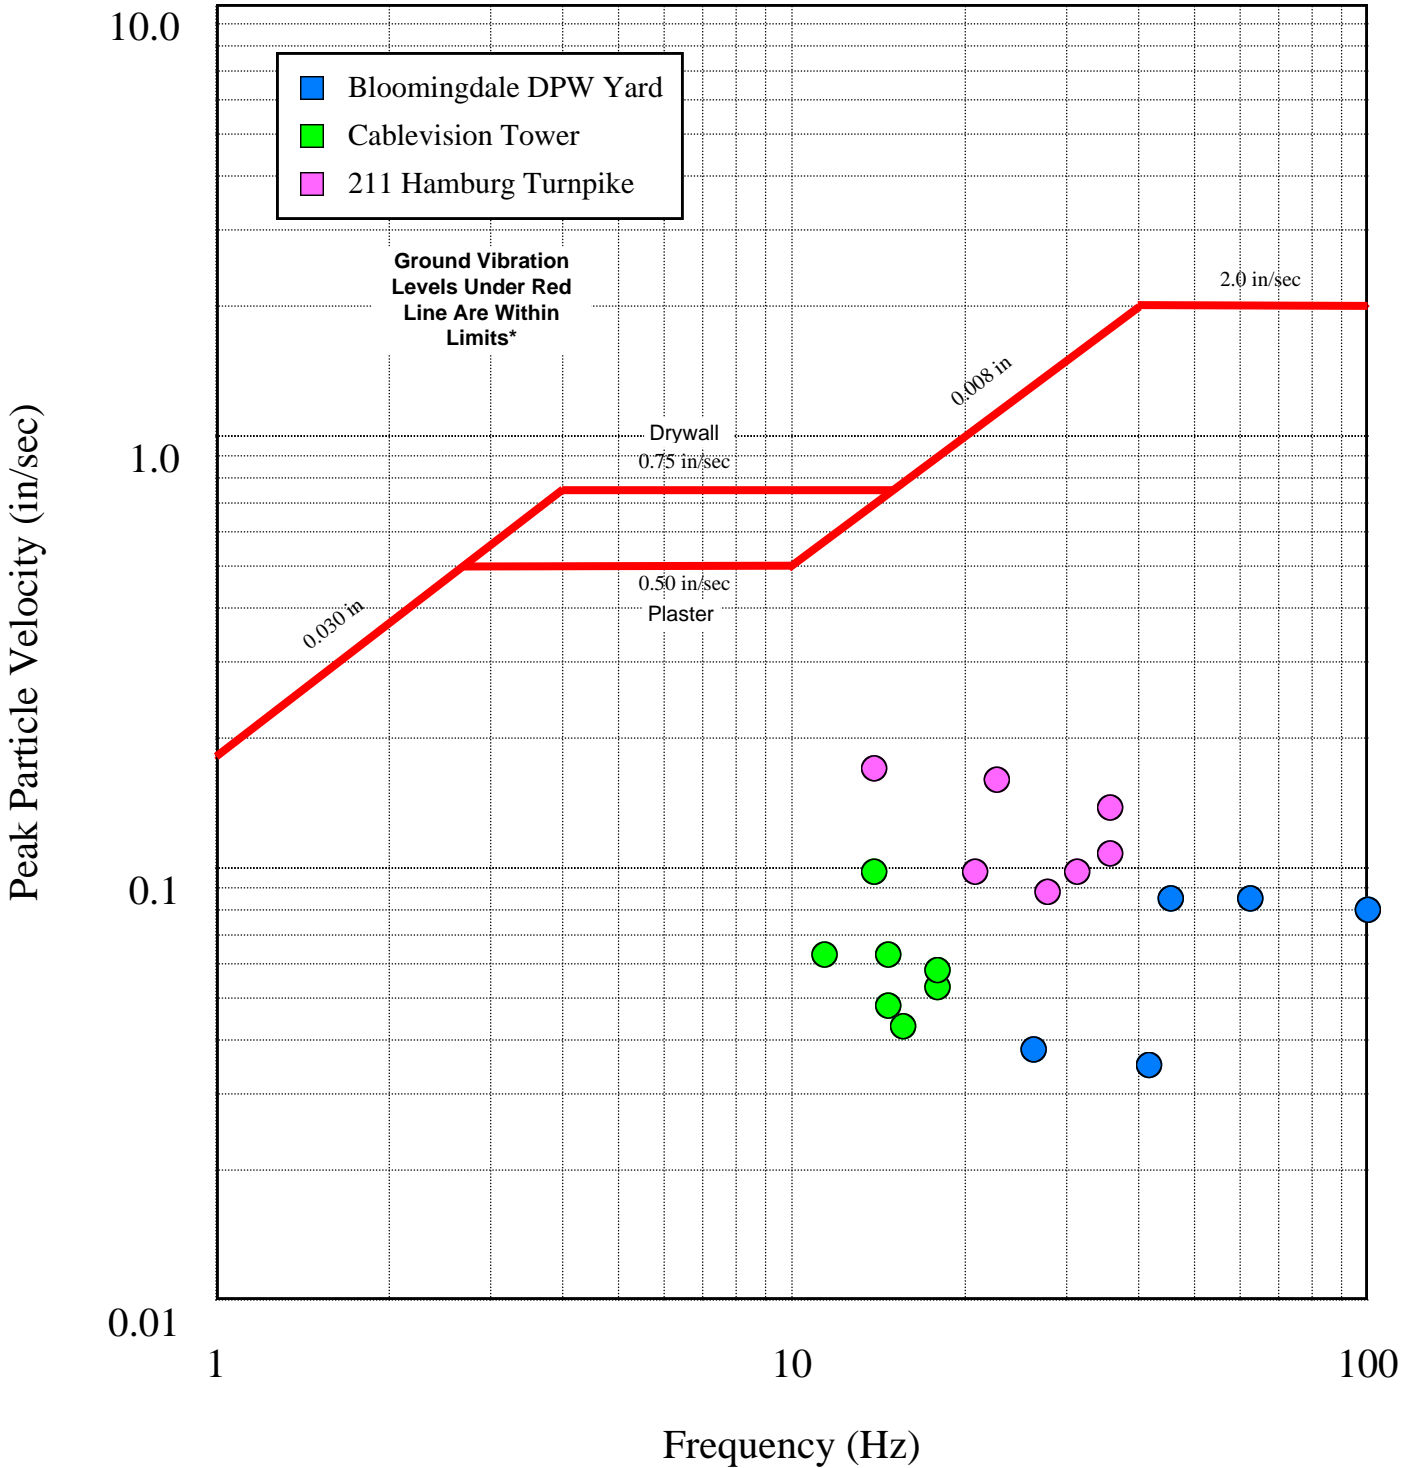
As per State of New Jersey Administrative Code Title 12:190; Subchapter 7.26

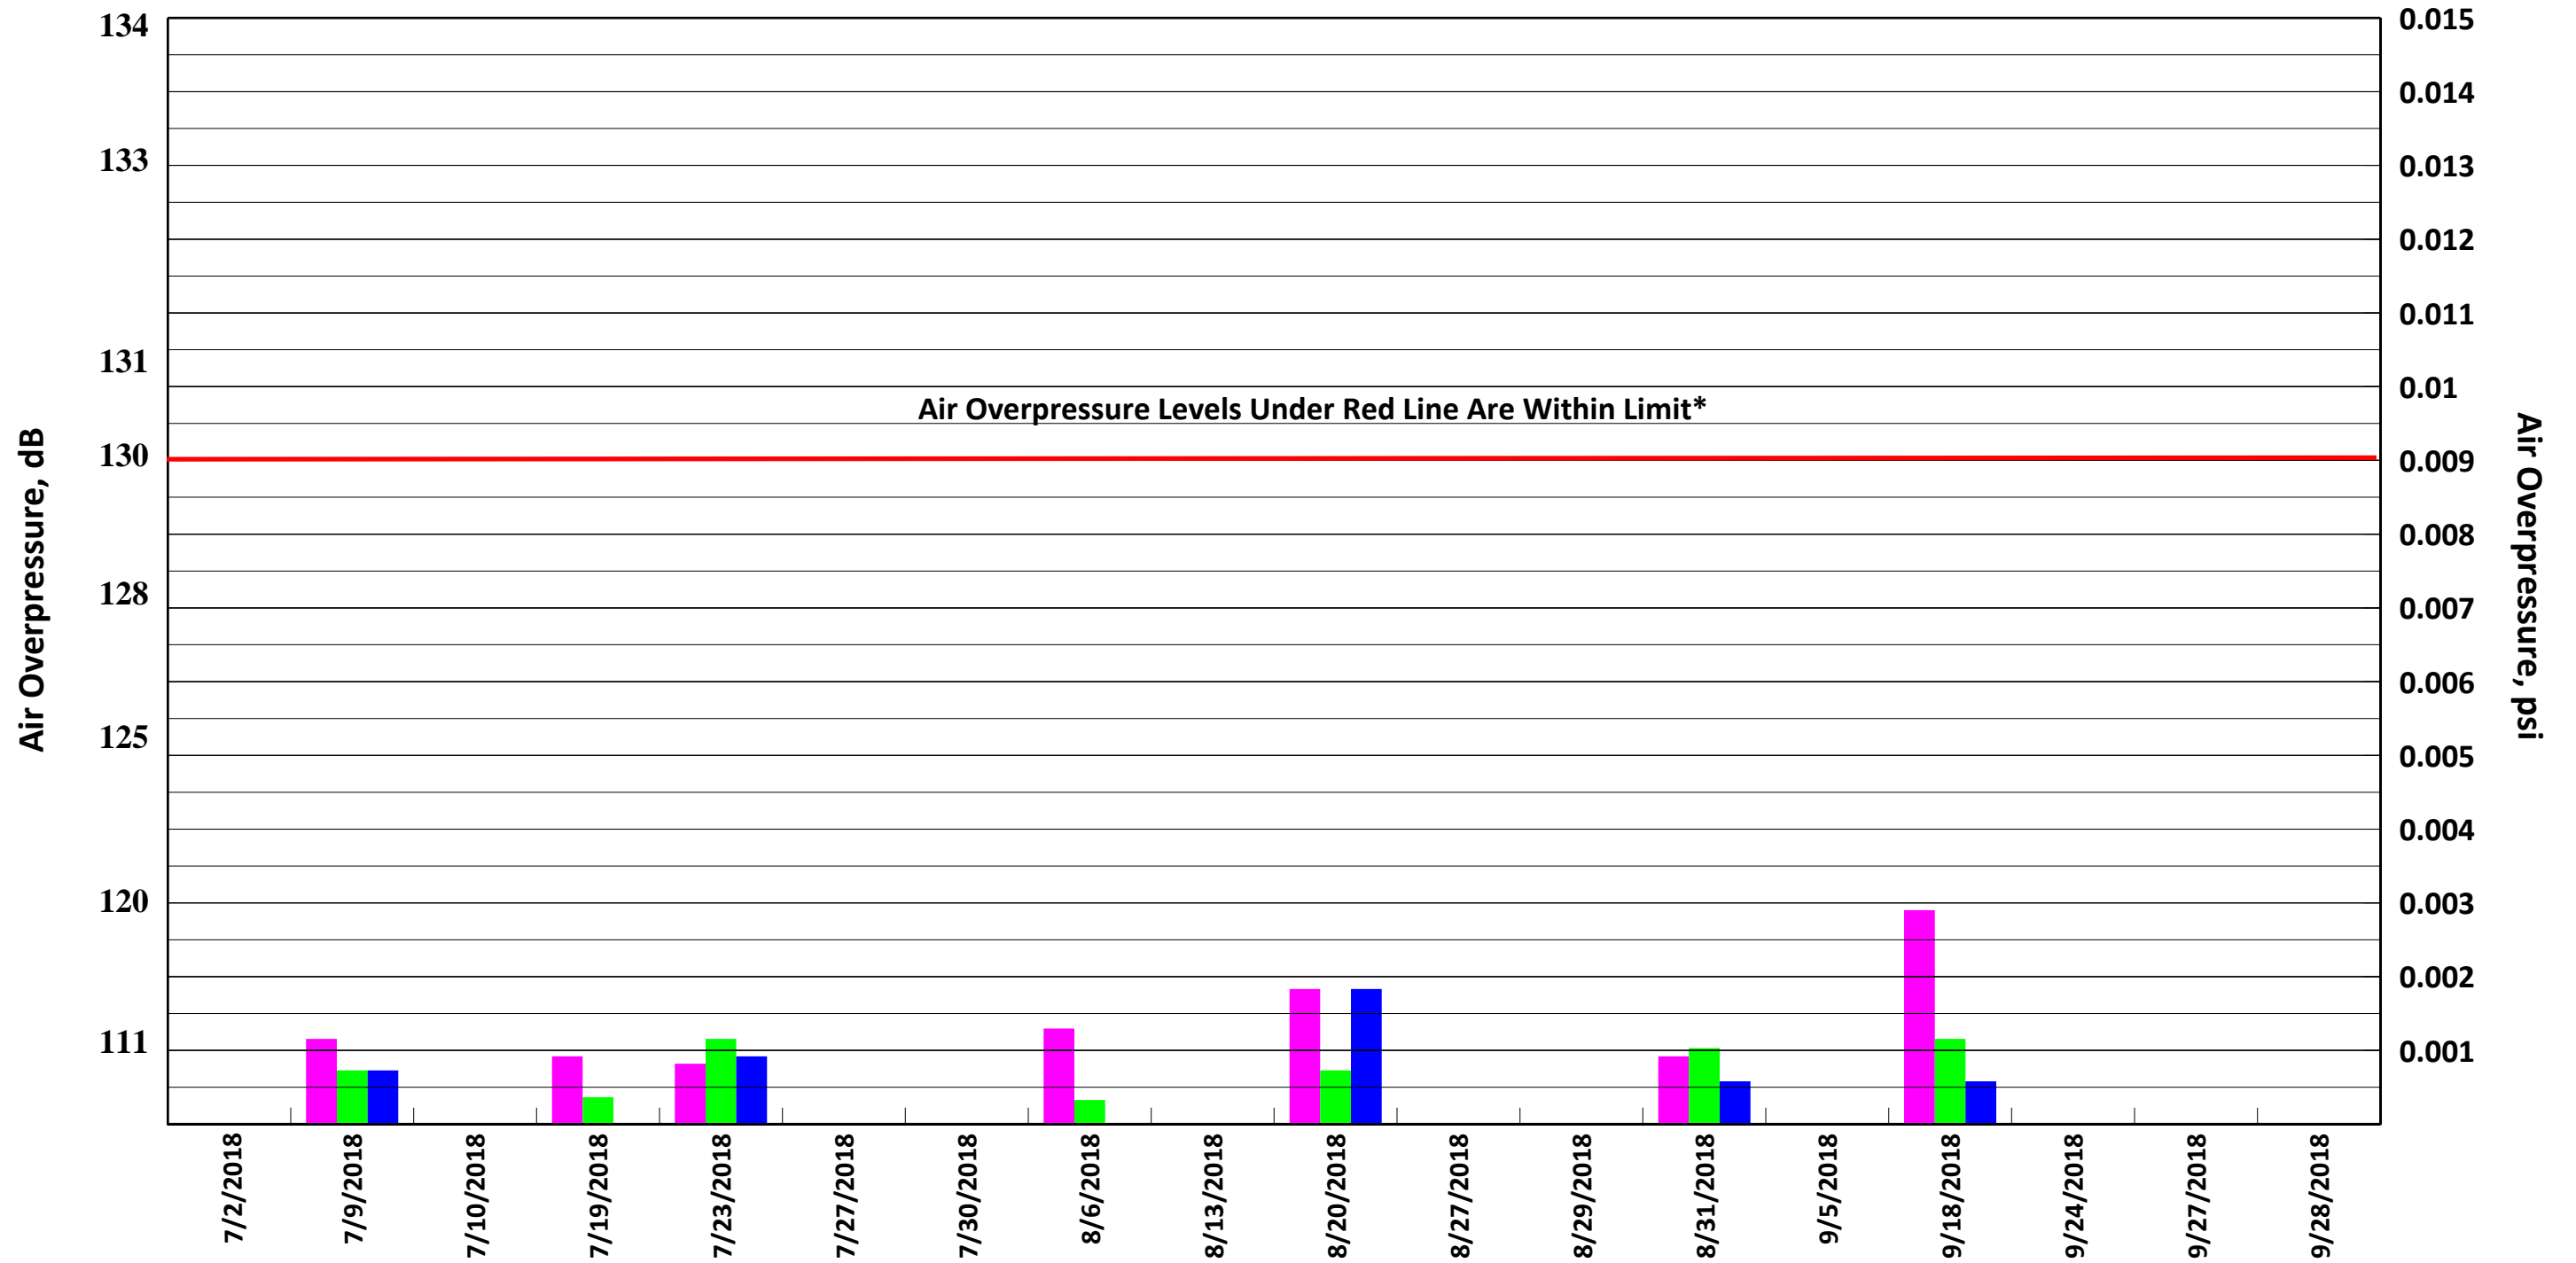
*As per State of New Jersey Administrative Code Title 12.190; Subchapter 7.25

■ 211 Hamburg Turnpike
 ■ Cablevision Tower
 ■ Bloomingdale DPW Yard
