**Tilcon New Jersey
 Pompton Lakes Quarry
 Quarterly Blast Data Summary
 3rd Quarter 2016**

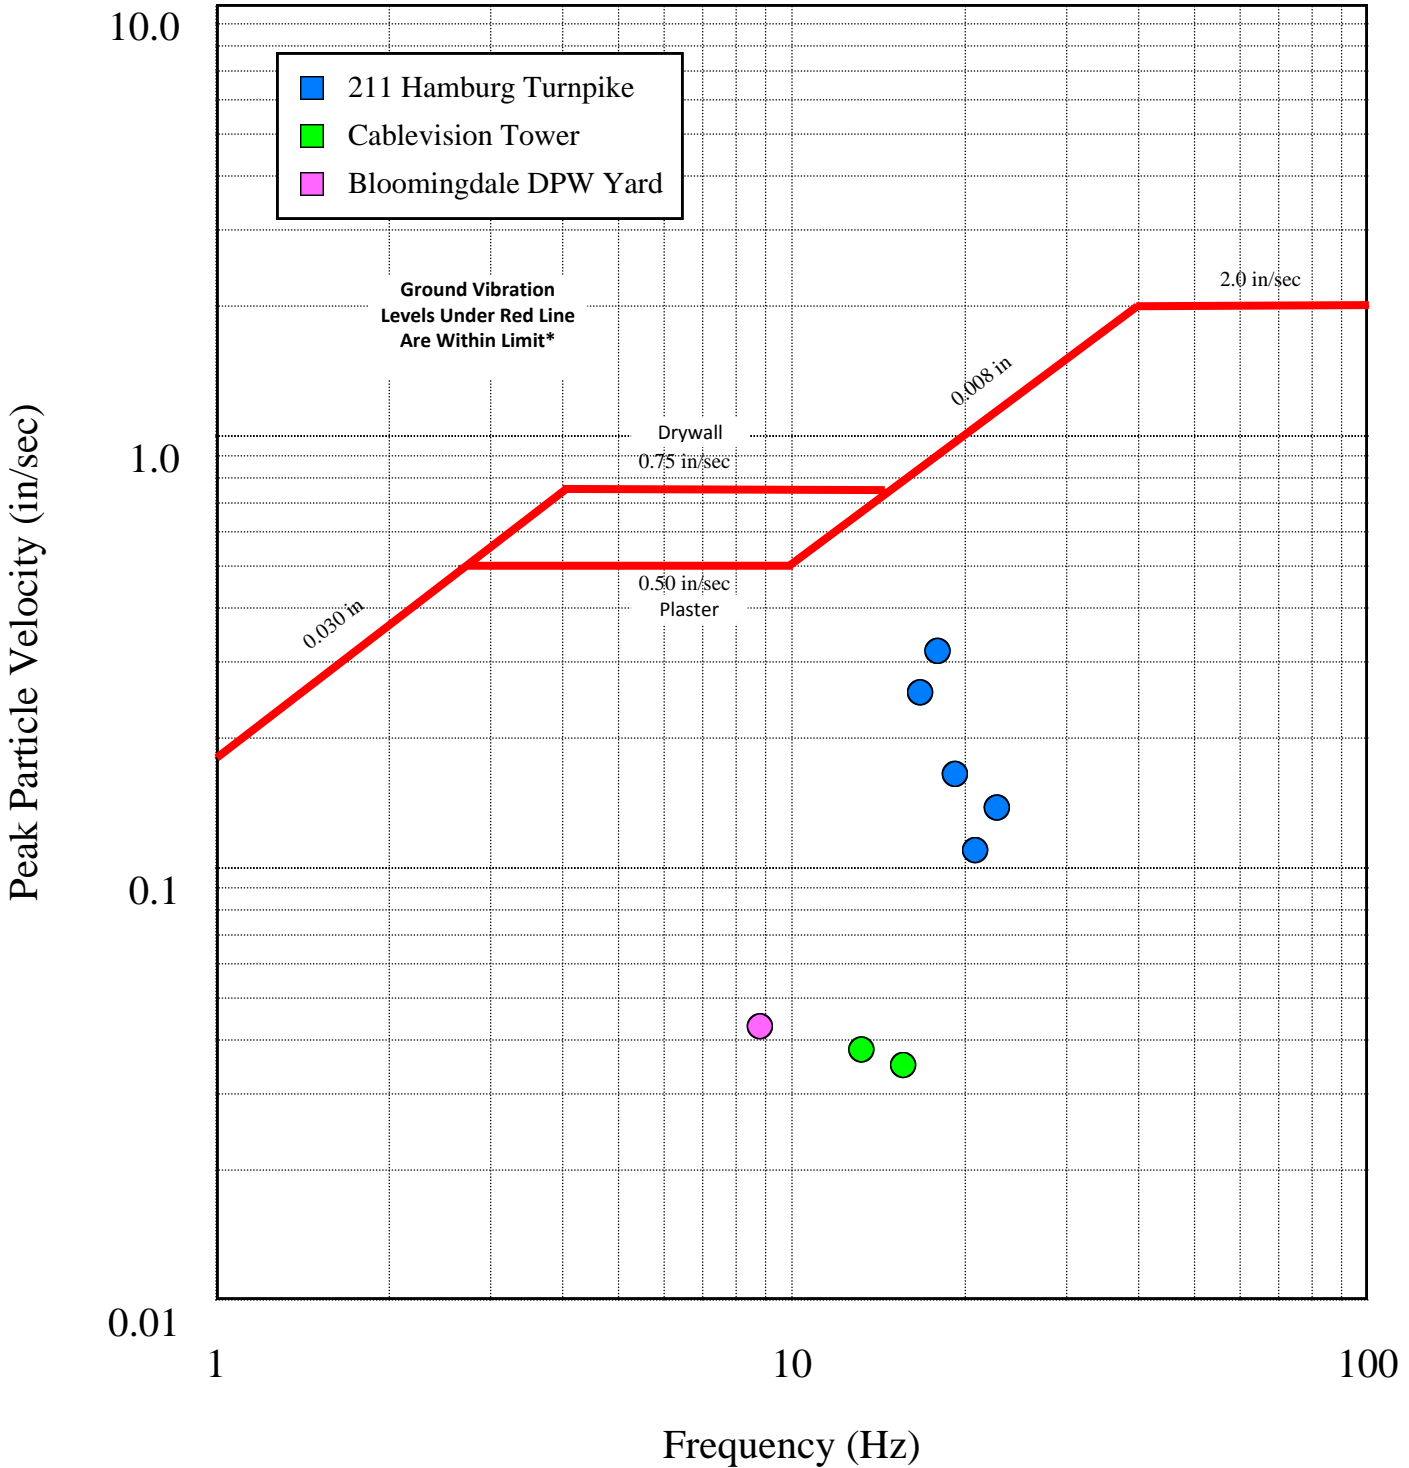
Comparison of Measured Blast Vibrations to Current U.S. Bureau of Mines Recommendations Tilcon New Jersey Pompton Lakes Quarry 3rd Quarter 2016

*As per State of New Jersey Administrative Code Title 12:190; Subchapter 7.26

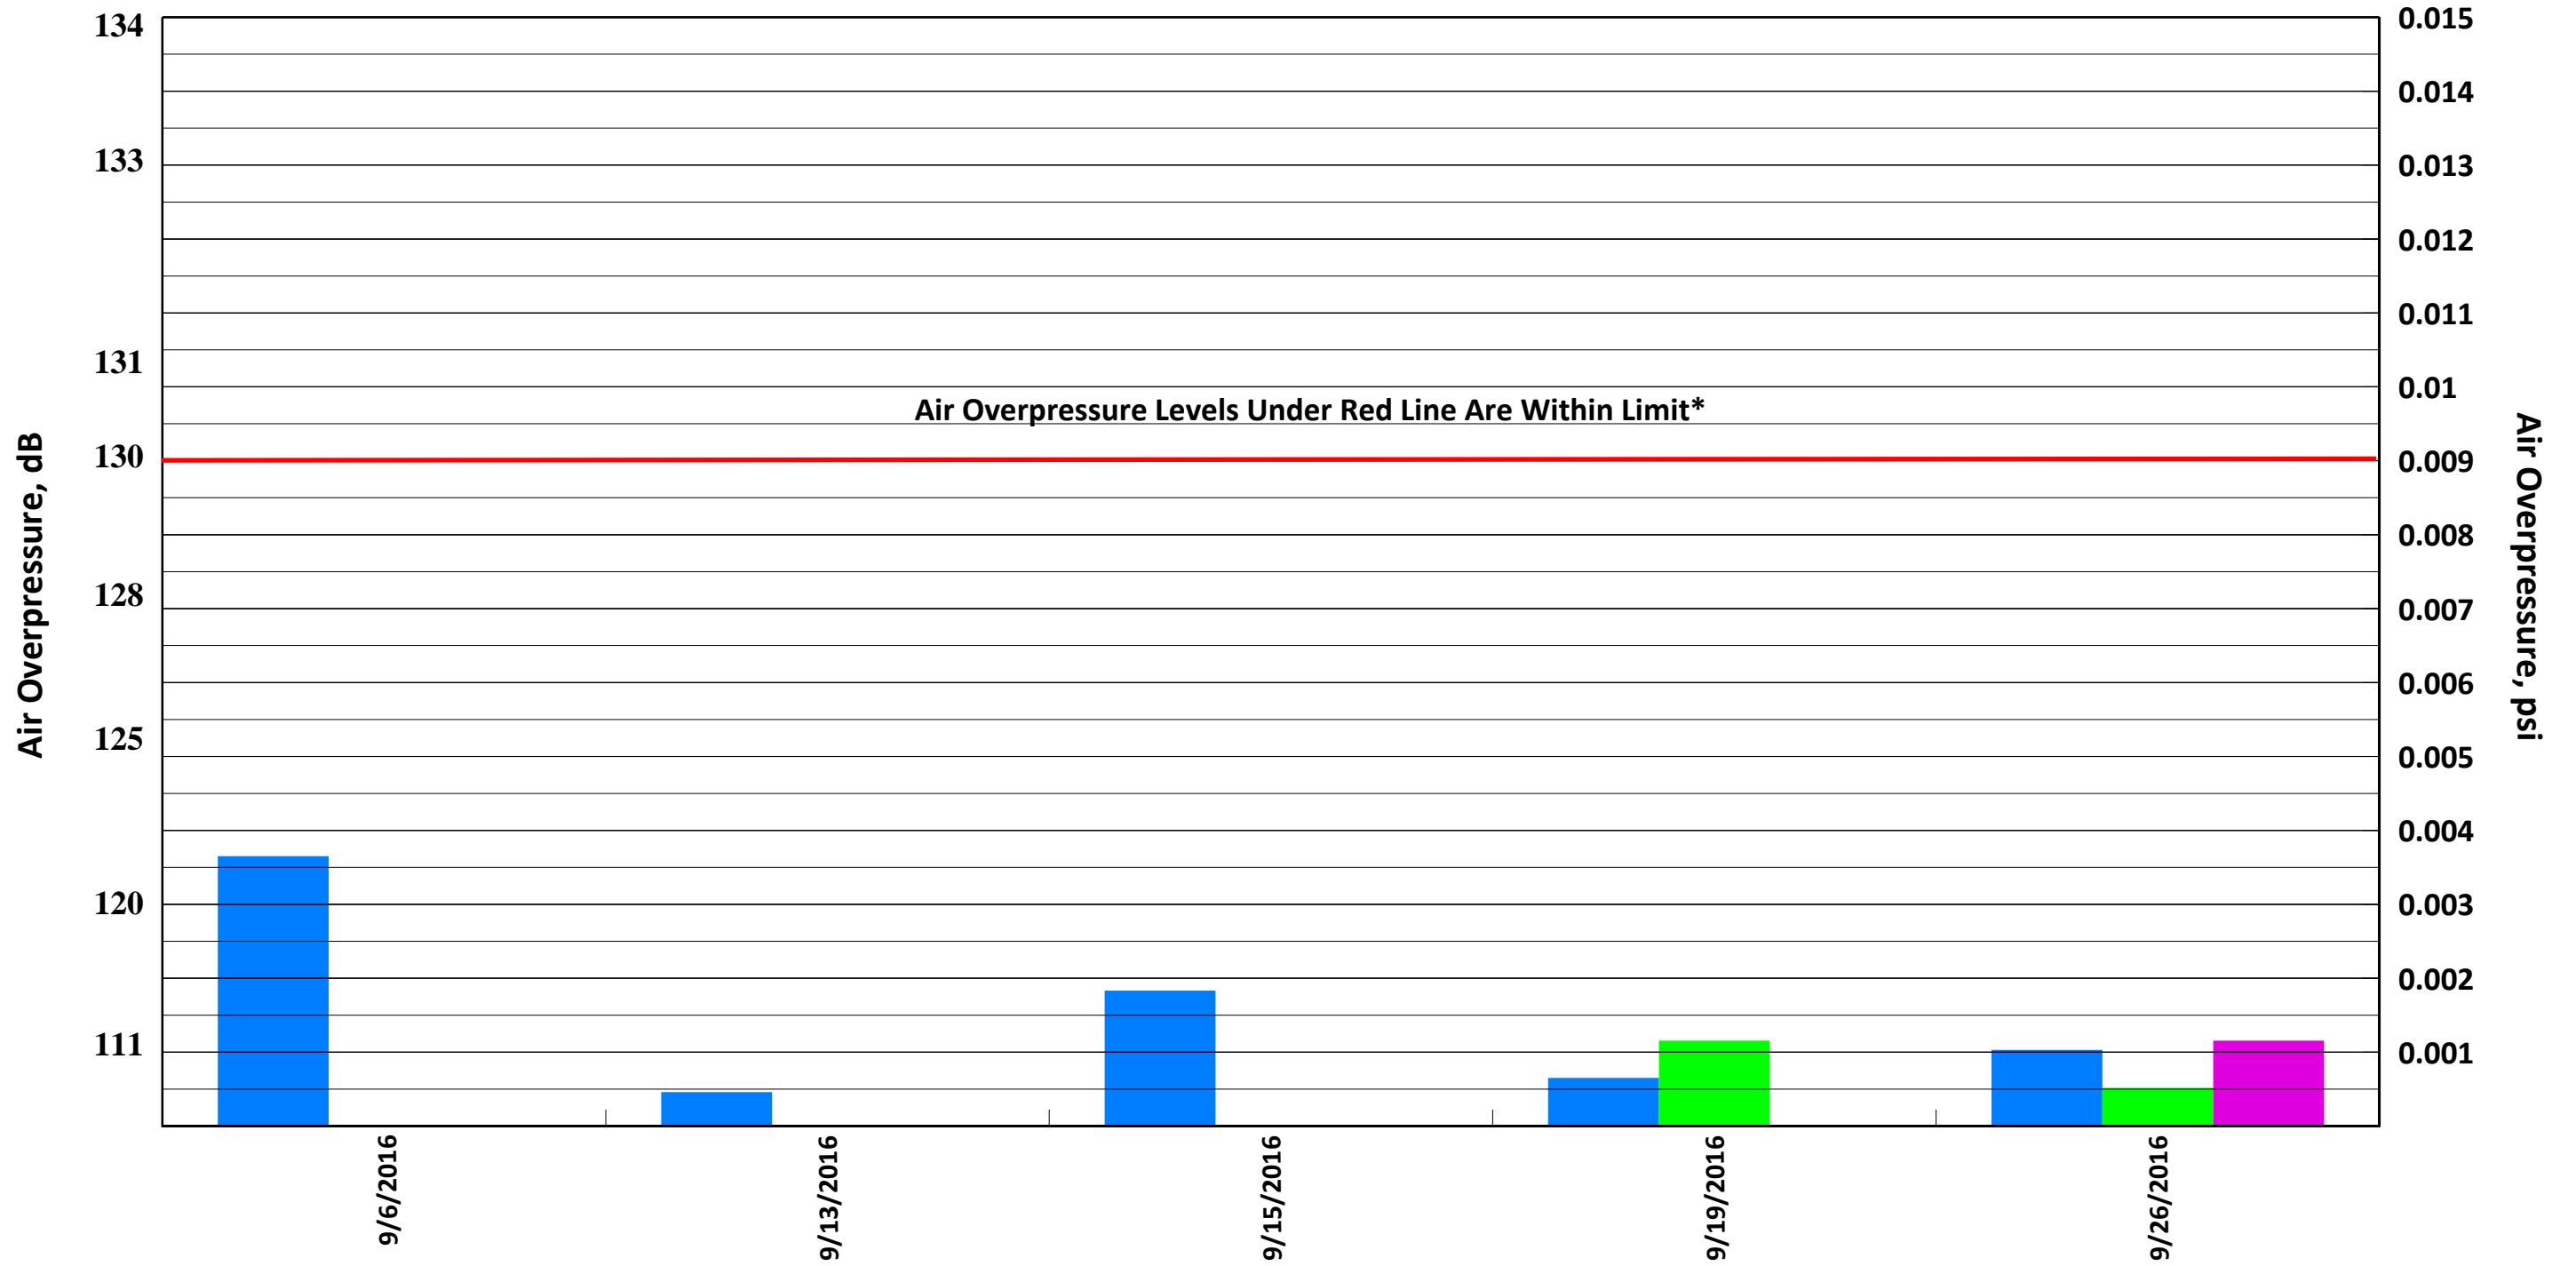
Air Overpressure Levels from Tilcon New Jersey - Pompton Lakes Quarry 3rd Quarter 2016

*As per State of New Jersey Administrative Code Title 12.190; Subchapter 7.25
